Manhole Inspection Summary

Manhole # S35YY_041MH

Insp Date: **3/2/07 1:20 PM**

Location Address: **100 32ND ST**

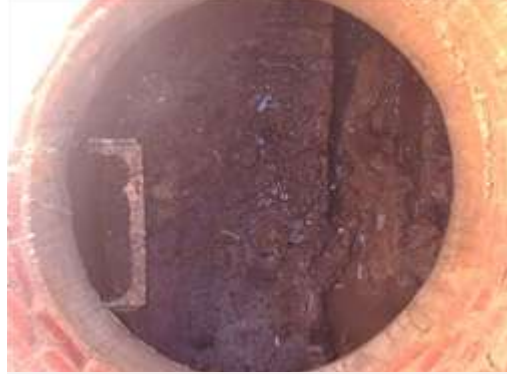
Top View

Evidence of surcharge - Bench debris.
Channel debris.

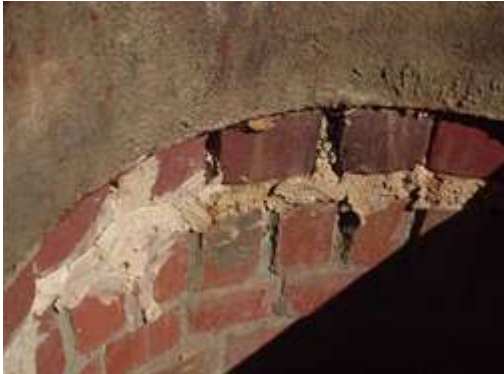
Defect

Frame leaks. Adjustment deterioration
and infiltration.

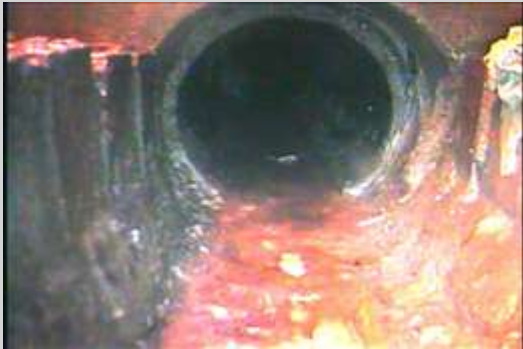
8 in. Circular Gravity Sewer Pipe Out @ 12 O'Clock

Deposits: ☐ None ☒ **Mud** ☐ Sludge ☒ **Debris** ☒ **Grease**

Silt Depth: **0** (in.) Deposits Extent: **Light**

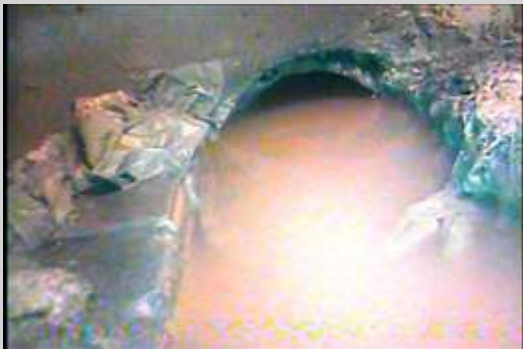
8 in. Circular Gravity Sewer Pipe In @ 6 O'Clock

Deposits: ☐ None ☒ **Mud** ☐ Sludge ☒ **Debris** ☐ Grease

Silt Depth: **3** (in.) Deposits Extent: **Medium**

Infiltration: **Evidence** Pipe Seal Cond: **Unknown**
